**Concrete Reinforcing Steel Corrosion**  
**Assessment, Re-passivation and Monitoring in an Industrial Environment**

**Bruce A. Collins, Vice President**  
**Restruction Corporation**  
**Sedalia Colorado**

Four separate concrete cooling towers at a coal fired electrical generation plant exhibited reinforcing steel corrosion causing concrete deterioration. The presentation will cover investigation of the corrosion sources, determination of the corrosion control solutions, implementation of the repair construction, and review of the corrosion measurements taken to prove effectiveness of the solution.

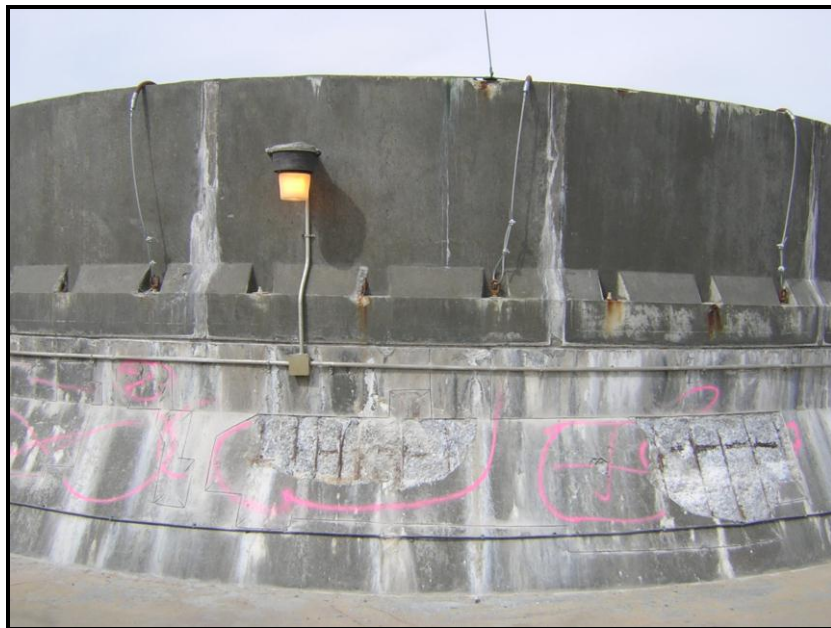
Figure 2. Upper and Lower Fanstack Assembly

Visual assessment of the lower assemblies determined several items including the high temperature environment, minimum concrete cover of  $\frac{3}{4}$ -inches and water seeping down the outer face of the assembly at the joint between the upper pre-cast and lower cast in place concrete. Constant contact with steam was causing elevated concrete temperatures and high moisture content. Each of these variables was contributing to the rebar corrosion. (See figure 2)

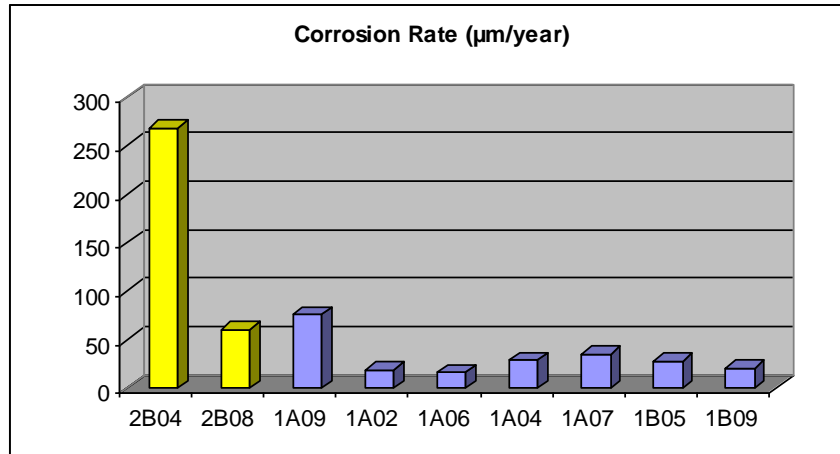
As project phase I was nearing completion in 2005, the plant engineering team raised the question of measuring the repair program success. Quickly a plan was implemented to measure corrosion. Luckily, Unit 2, the second phase of the project was still in the active corrosion mode. Unit 1, consisting of 24 assemblies in the first phase, was repaired and the reinforcing steel re-passivated. The corrosion measurement plan was to measure corrosion current, corrosion potential and concrete resistance at two fan stack locations on Unit 2. These locations would be considered pre-repair and serve as the baseline. Corrosion rates and potentials were not taken during the investigation phase. It was apparent that corrosion was occurring and the source of initiation was the high concrete temperatures and moisture levels. Further, no future monitoring of the corrosion was planned during the investigation phase. Measuring corrosion rate, potential and concrete resistance at 7 locations on Unit 1 would serve as the post repair condition and provide a comparison to pre-repair condition measured at Unit 2. A Galvapulse corrosion rate meter was used to record approximately 12 readings per assembly. The results were graphed. (See figures 5, 6 and 7) An immediate concrete resistance effect was measured. All seven Unit 1 assemblies measured post repair had higher concrete resistance than the two Unit 2 pre-repair assemblies. On average resistance was up 135%. Corrosion rate measured in micro-meters per year also showed immediate improvement. Six of seven post repaired corrosion rates were below both pre-repaired rates. On average corrosion rate was reduced 80%. Corrosion potential showed immediate improvement as well. Adjusted for the Silver/Silver chloride half cell, Copper Sulfate Electrode readings in the pre-repair were -315mV CSE and -360 mV CSE. The average post repair potential was measured at -270 mV CSE. ASTM Standard indicates that for potentials between -200 mV and -350 mV CSE indicate that corrosion is "uncertain". Readings more positive than -200 mV indicate with 90% confidence that no corrosion activity is present.

Figure 5. Data Labeled “2B” are Pre-Repair values. Data Labeled “1A” and “1B” are immediate post repair values.

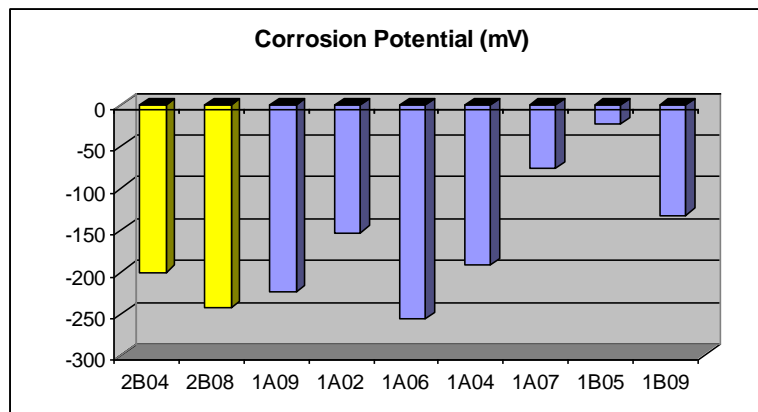
Figure 6. Data Labeled “2B” are Pre-Repair values. Data Labeled “1A” and “1B” are immediate post repair values.

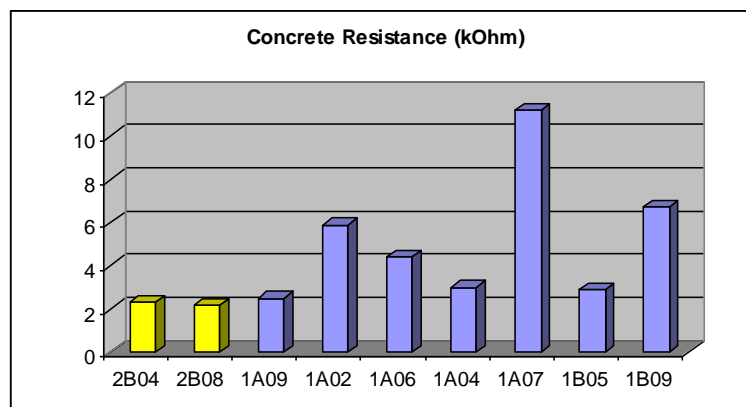
Figure 7. Data Labeled “2B” are Pre-Repair values. Data Labeled “1A” and “1B” are immediate post repair values

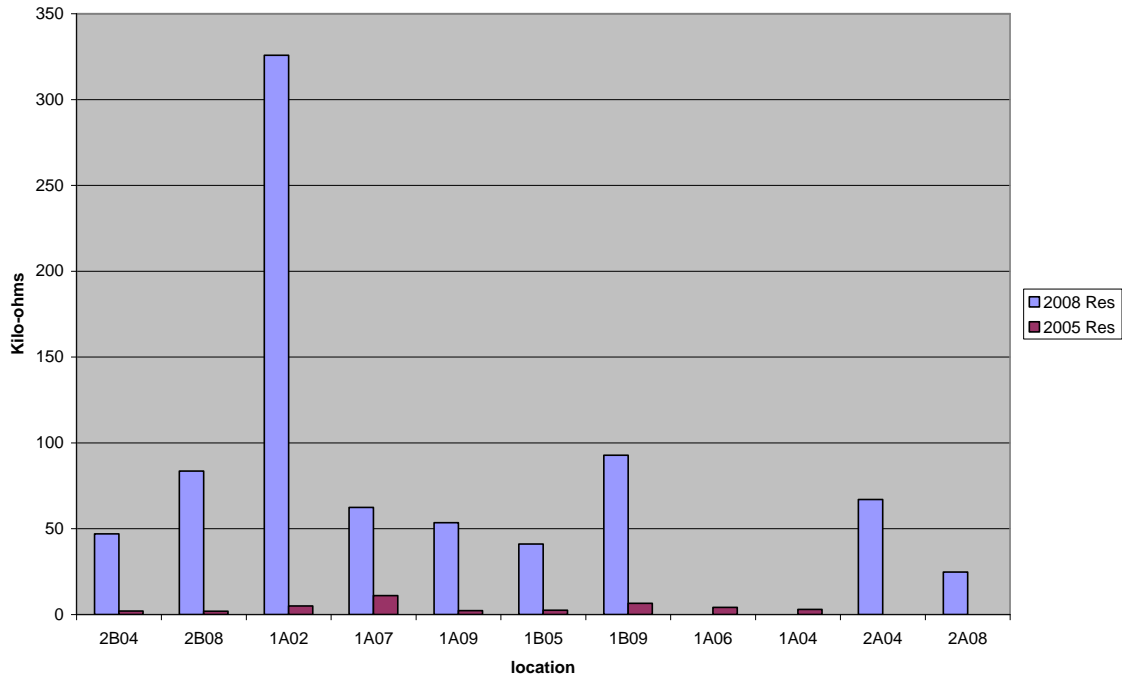
Figure 8. Year 2005/2008 Comparative Resistance Data

The plant engineering team budgeted additional funds for repair of Unit 2 assemblies to be completed spring/summer 2008. Three years had passed since completion of Unit 1 repairs. Again corrosion measurements were taken upon completion. The same two locations on Unit 2 were measured providing a direct comparison of pre-repair (year 2005) and post repair readings. Five of the original seven assemblies at Unit 1 were re-measured. This provided a comparison of readings immediate post repair and repair, plus three years time. Two new locations at each Unit 1 and Unit 2 were also recorded. Results still indicate the reinforcing steel is passive. (See figures 8, 9 and 10) Concrete resistance has improved in both Unit 2 pre-repair and post repair measurements and in Unit 1 from measurements recorded in 2005 and 2008. Average concrete resistance is continuing to improve. Unit 1 resistance has increased from 49 kilo-ohms immediate post repair to 115 kilo-ohms measured 3 years later. Regarding corrosion current, a U.S. standard has not been developed. However a Norwegian proposed standard indicates values of 11.5-58 micro-meters per year would be considered low corrosion. Less than 11.5 micro-meters per year indicate negligible corrosion. The Norwegian standard converts corrosion rate units of micro-amps per centimeters squared to cross-section loss of reinforcing steel using Faradays Law. This corrosion rate measurement is Unit 1 was repaired in 2005 and is currently showing low to negligible corrosion activity. The rebar in Unit 1 remains passive due to the implemented repair scheme. Unit 2 assemblies that

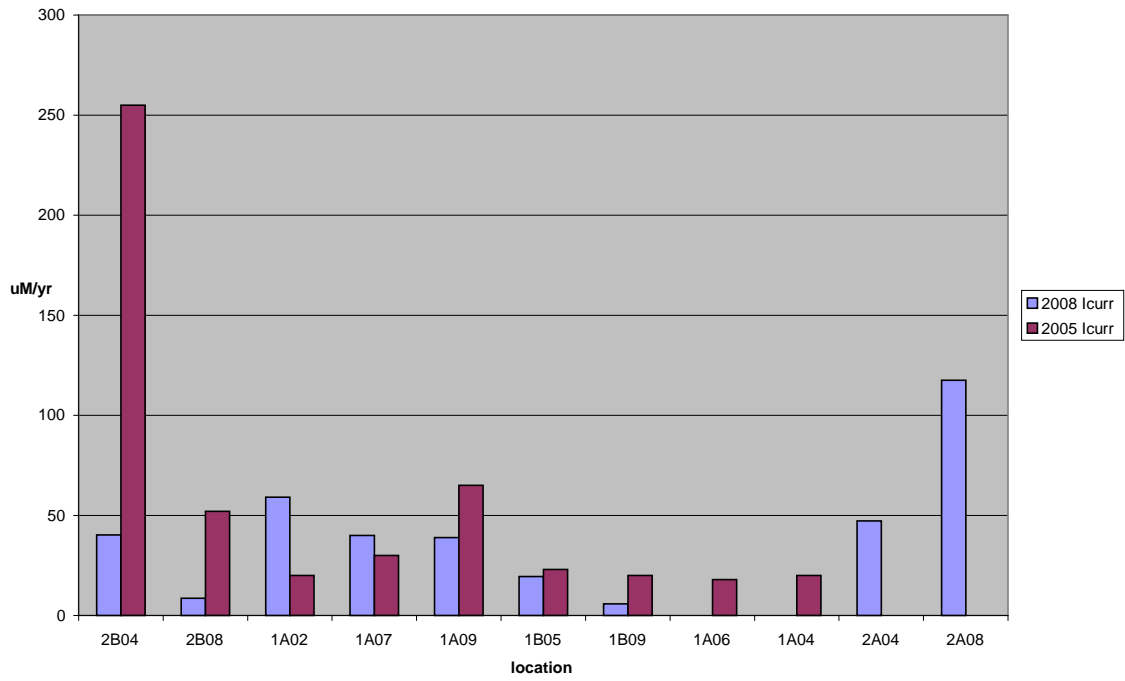
Figure 9. Year 2005/2008 Comparative Corrosion Rate Data

were measured prior to repair in 2005 and then again post repair in 2008, currently have corrosion currents in the low to moderate corrosion activity levels. The corrosion current levels have dropped significantly. I expect the corrosion currents to continue dropping as the rebar becomes more passive. Based upon these results, the plant engineering team believes that the project started in the year 2000 and concluded in 2008 was successful.
